**CERCLA
EXPANDED SITE INSPECTION ADDENDUM REPORT**

Eagle Zinc Company

Hillsboro, Montgomery county, Illinois

September 1, 2005

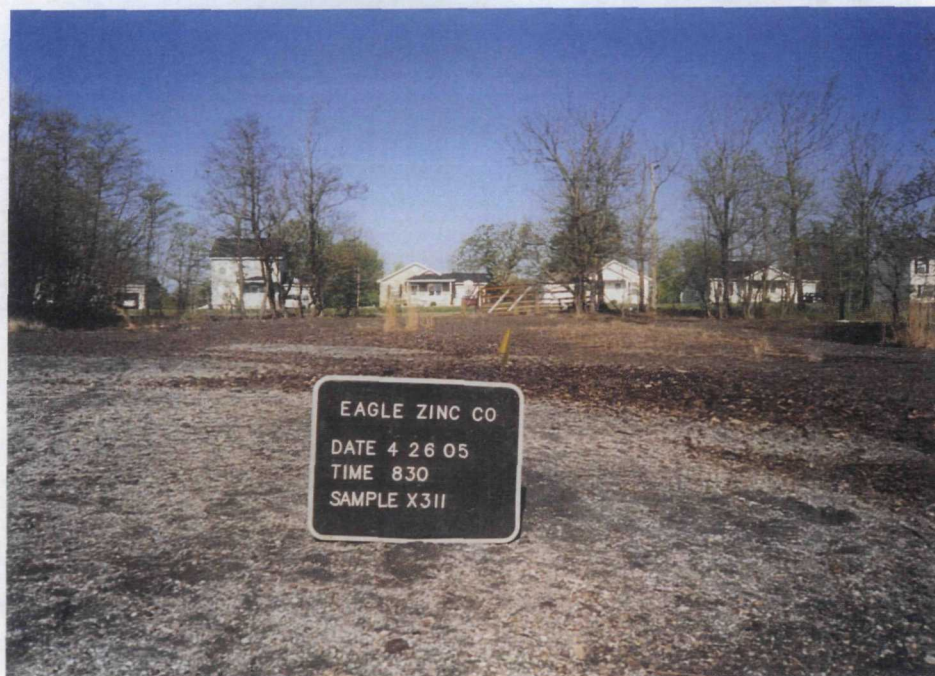
Photo Number 19.

Sample X311 was
collected at the
west area of the
site. Houses lie
across the street.

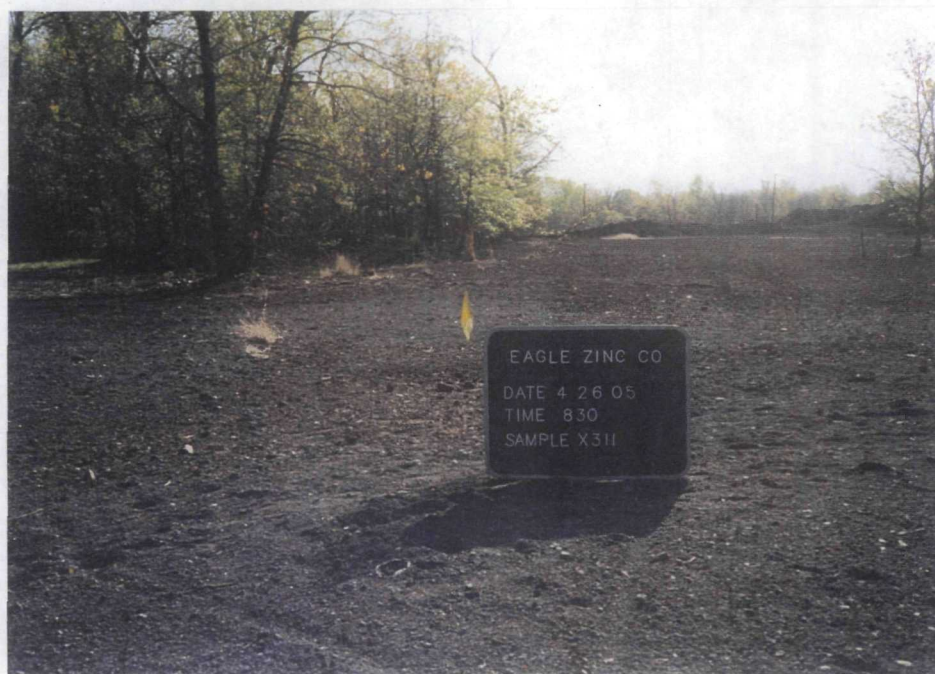
Photo Number 20.

Sample X311. The
sample consisted
of a medium gray
slag fines, from a
depth of 0 to 1/2
inches.

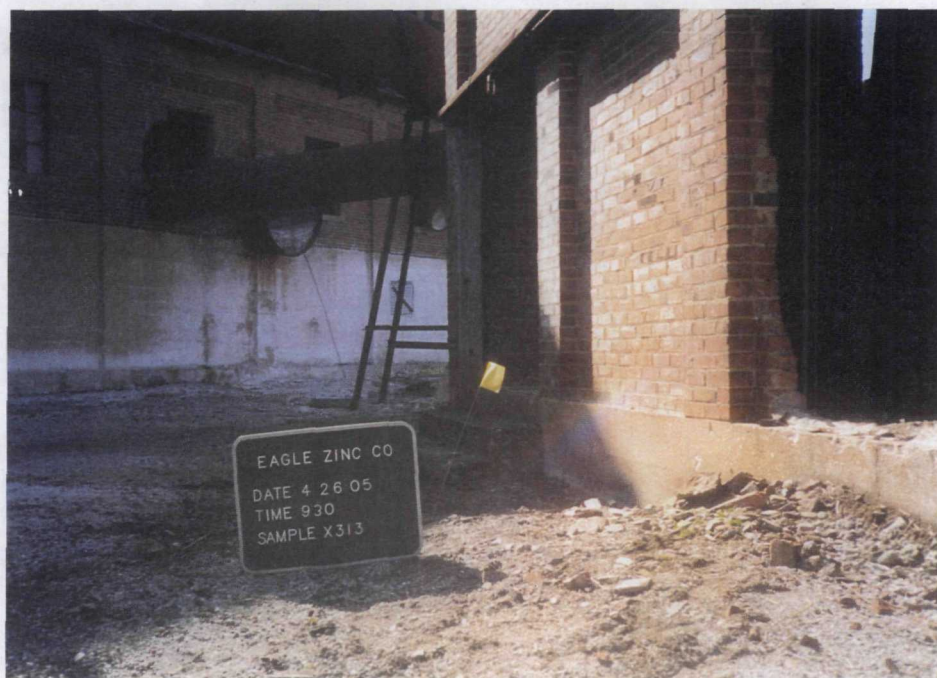
Photo Number 23.

Sample X313 was
collected at the
northeast area of
the site from a
slag pile.

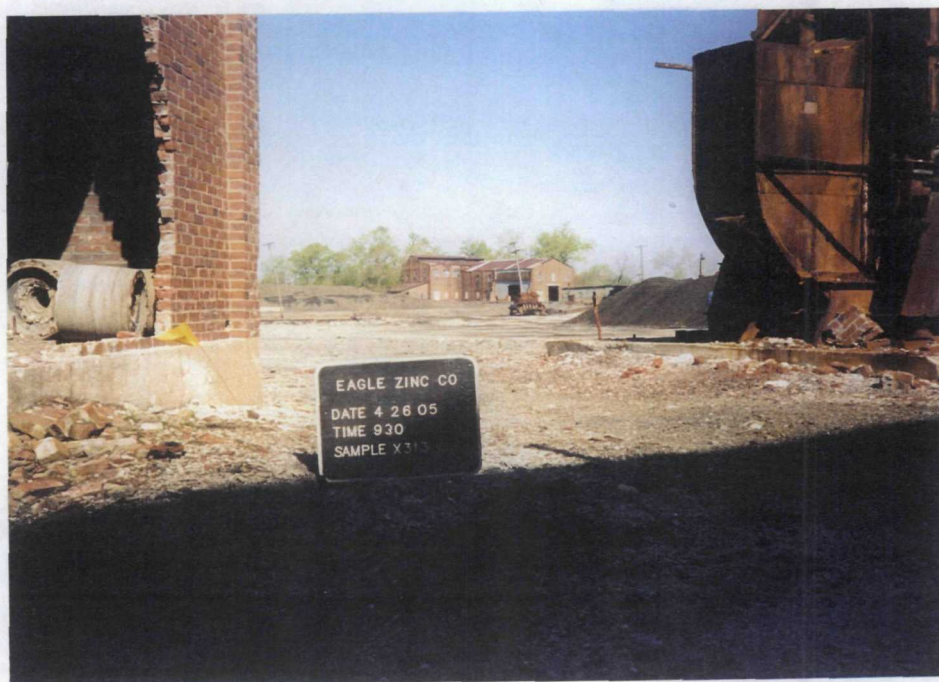
Sample X313. The
sample consisted
of a fine light
gray material with
white fragments.

Depth 0 to ½ inches

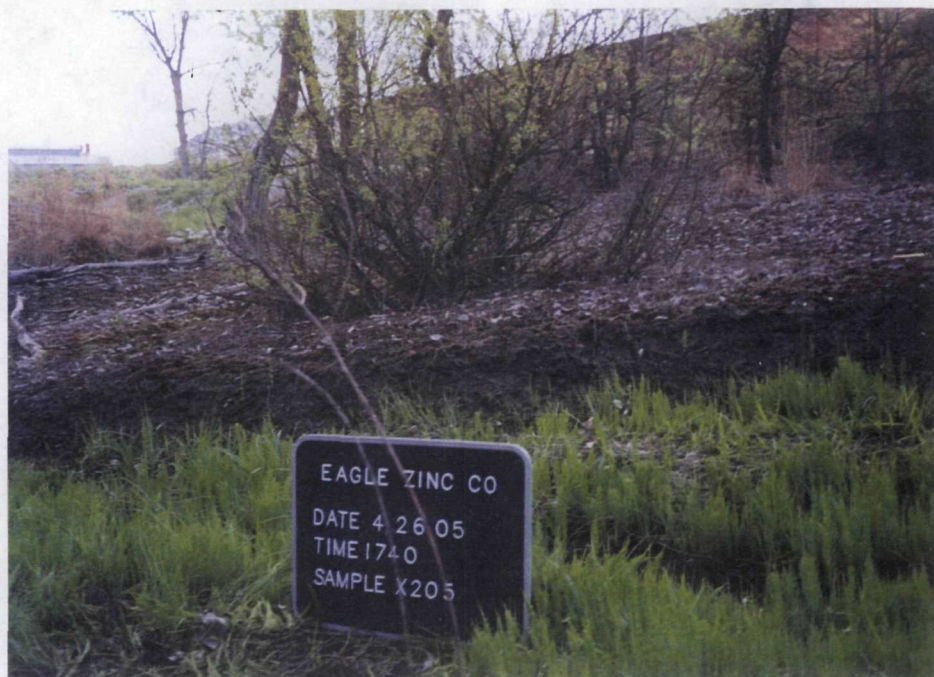
DATE: 4/26/05
TIME: 17:40
PHOTOGRAPH TAKEN BY: R. CASPER
COMMENTS: Picture taken toward: East.
Photo Number 38.
Sample X205. The sample consisted of a brown silty clay collected from 0 to ½ inches.

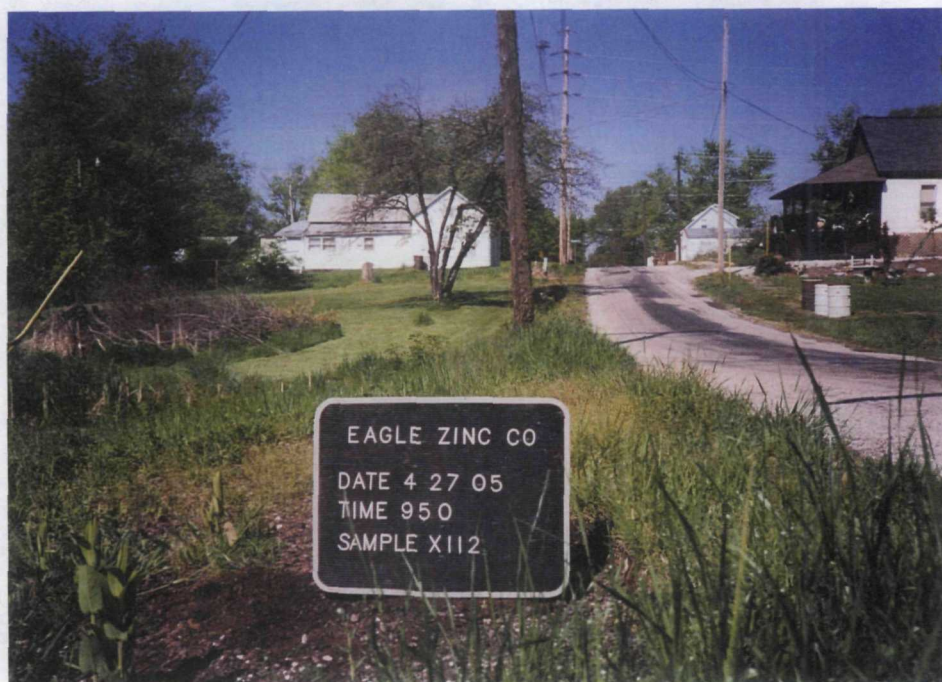
Photo Number 45.

Sample X112 was
collected from a
residential area
west of the site.

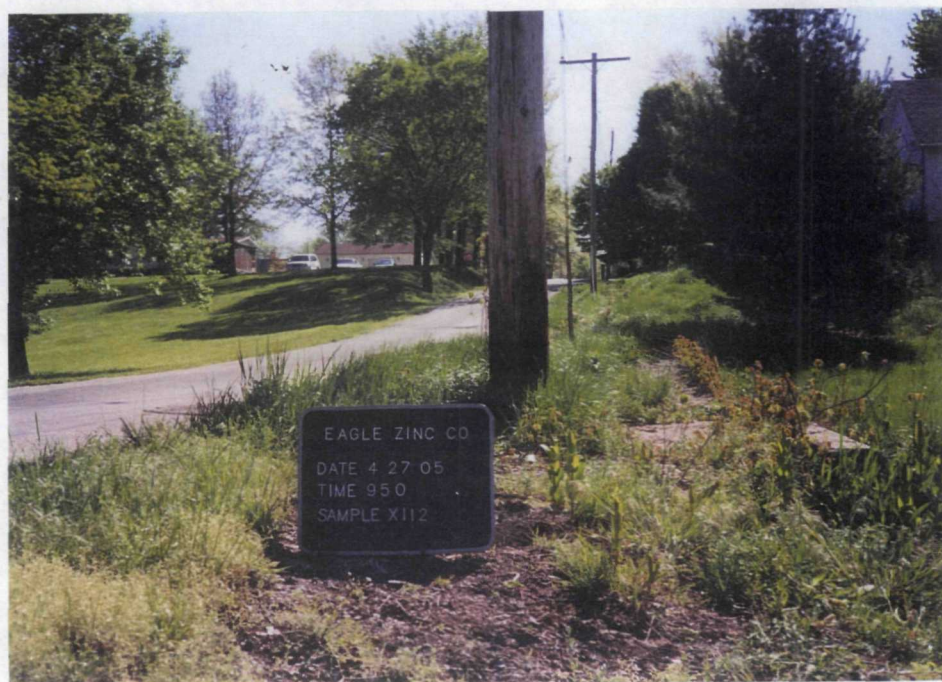
Photo Number 46.

Sample X112. The
sample consisted
of reddish-brown
cinders and slag,
collected from a
depth of 0 to 2".

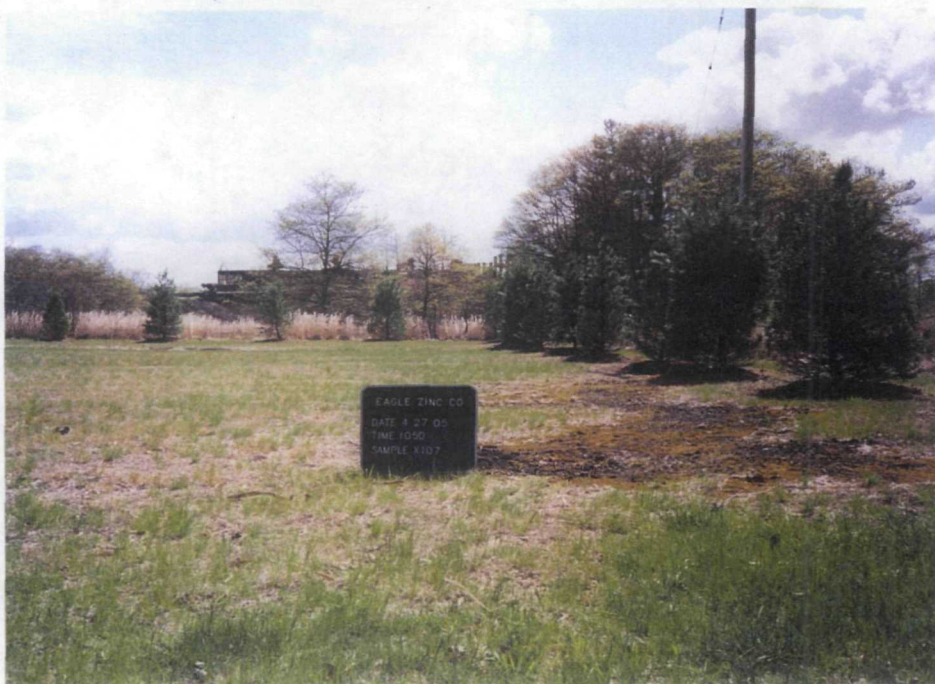
Photo Number 49.

Sample X107 was
collected from a
field west of the
site near a
residential area.

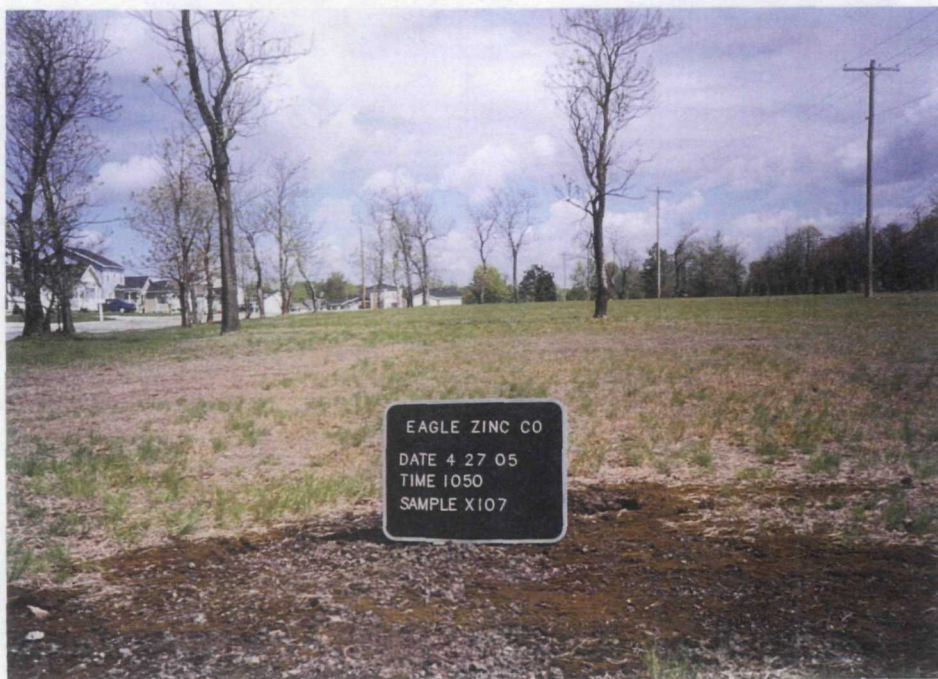
Photo Number 50.

Sample X107. The
sample consisted
of a slag material
over clay, collect-
ed at depth of
0 to 1 inch.

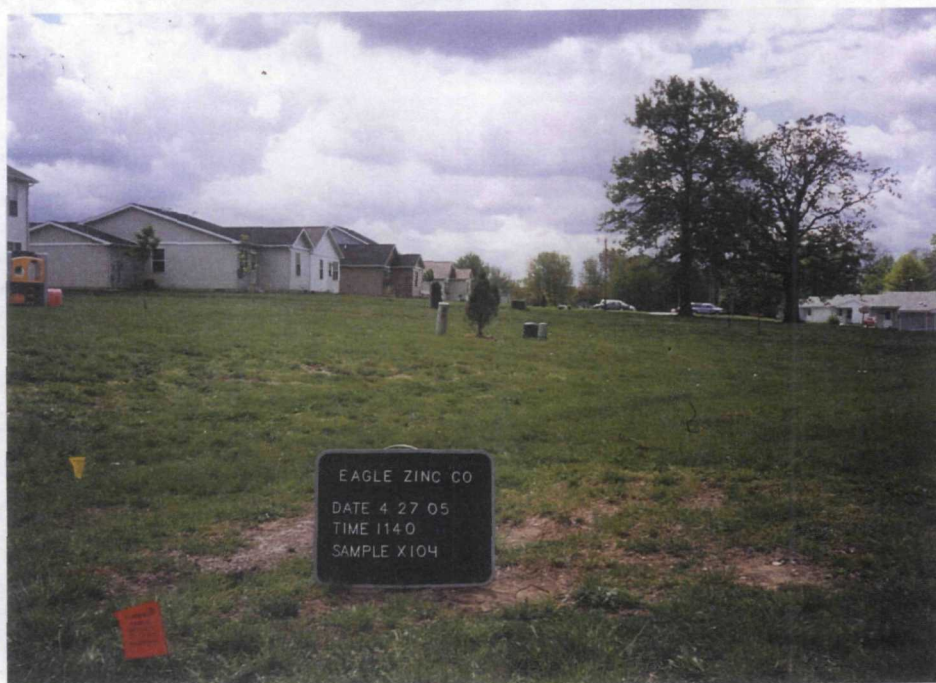
Photo Number 51.

Sample X104 was
collected from a
residential yard
northwest of the
site.

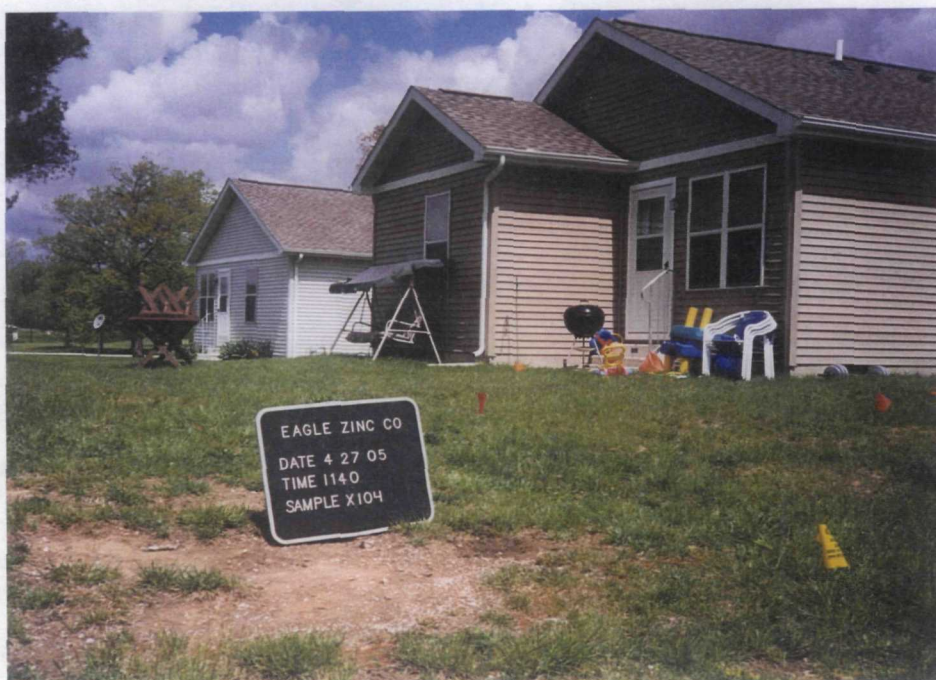
Photo Number 52.

Sample X104. The
sample consisted
of a brown-black
clay, collected at
a depth of 0 to 1
inch.

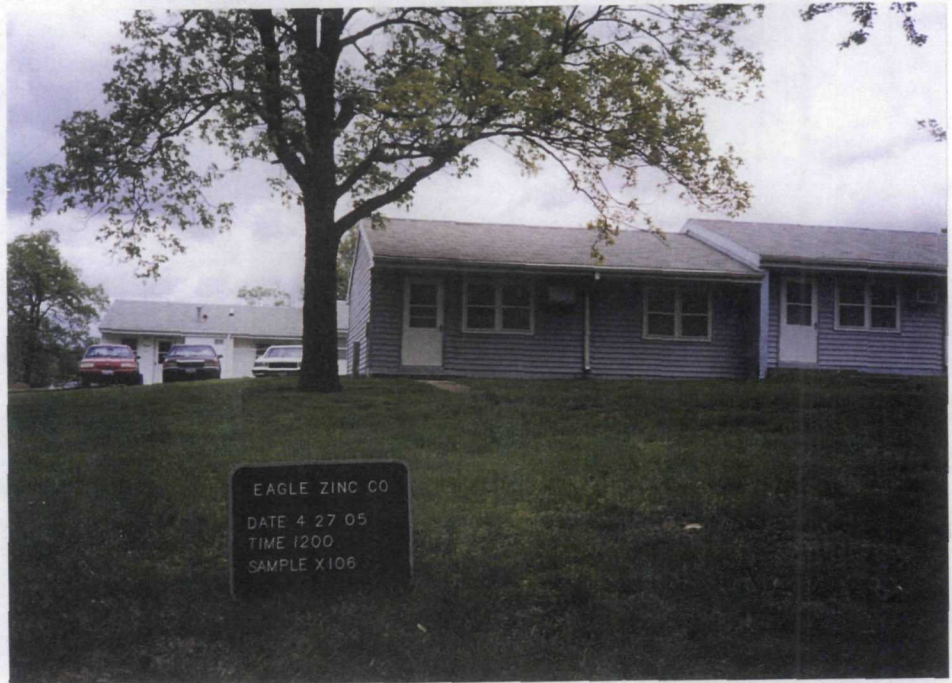
Photo Number 53.

Sample X106 was
collected from a
public housing
project northwest
of the site.

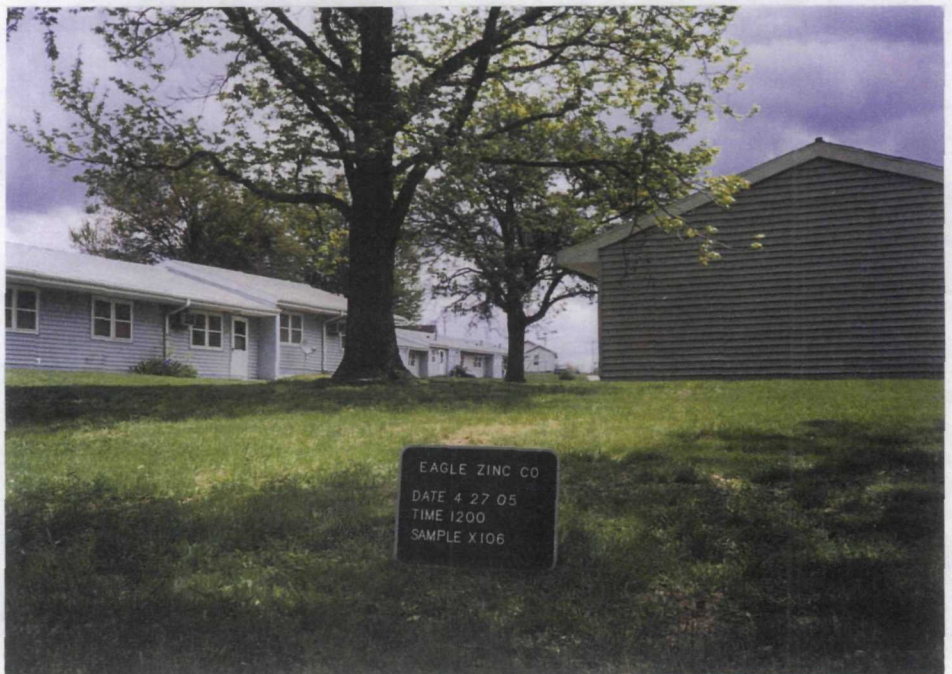
Photo Number 54.

Sample X106. The
sample consisted
of a brown-black
clay loam collected
at a depth of 0
to 2 inches.

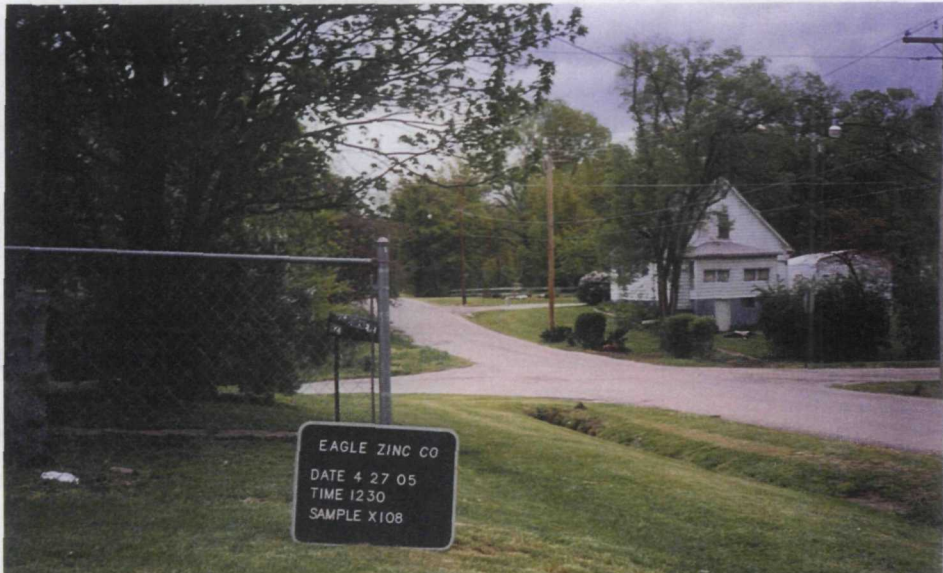
COMMENTS: Picture taken toward: East.		
Photo Number 55.		
Sample X108 was collected from a residential yard west of the site.

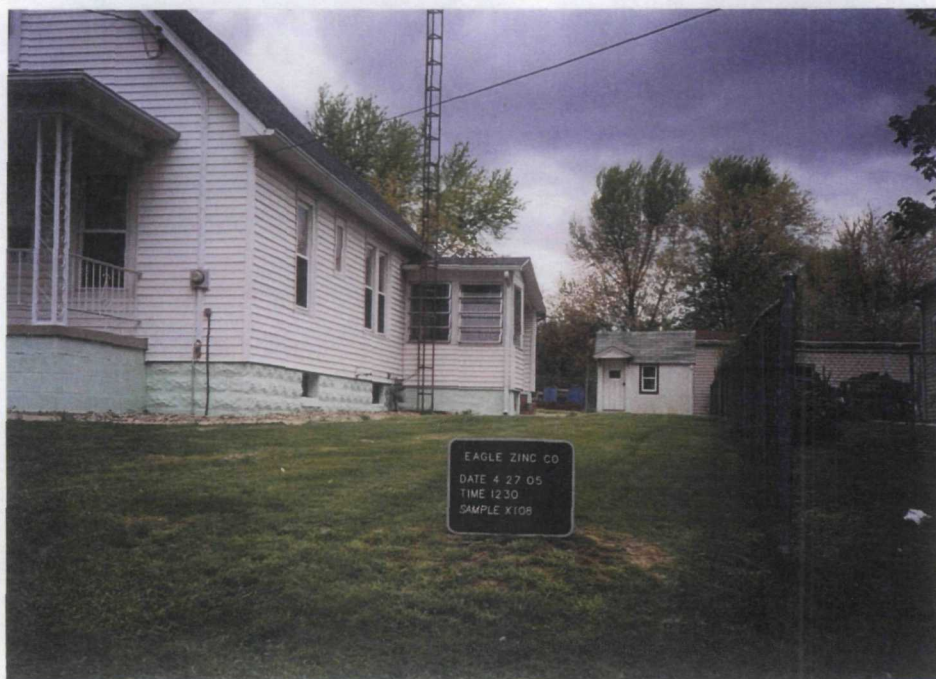
DATE: 4/27/05
TIME: 12:30
PHOTOGRAPH TAKEN BY: R. CASPER
COMMENTS: Picture taken toward: North.
Photo Number 56.
Sample X108. The sample consisted of a light brown clay loam collected at a depth of 0 2 inches.

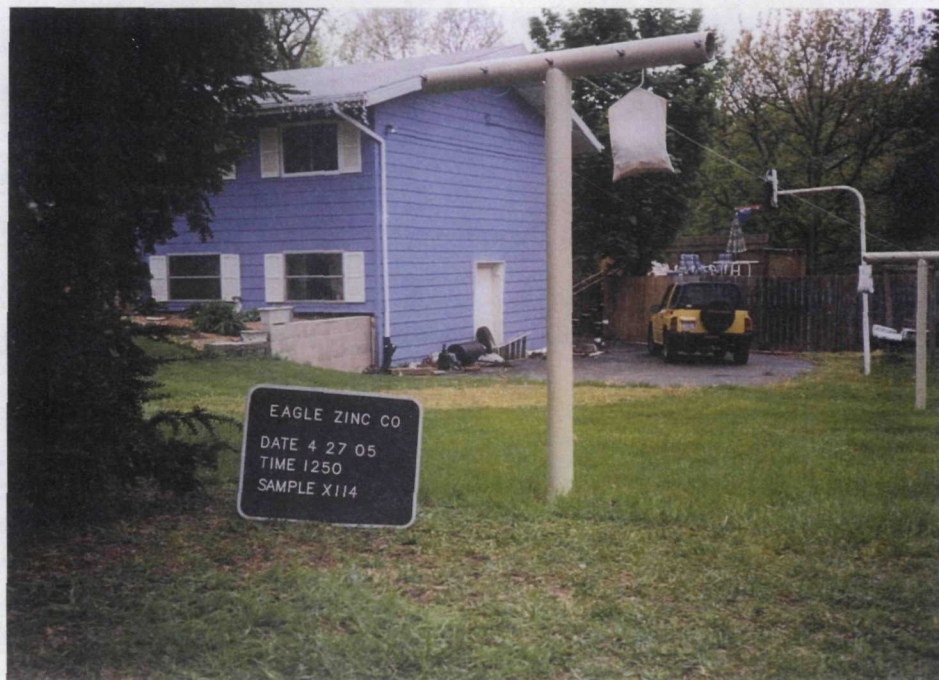
Photo Number 57.

Sample X114 was
collected from a
residential yard
northwest of the
site.

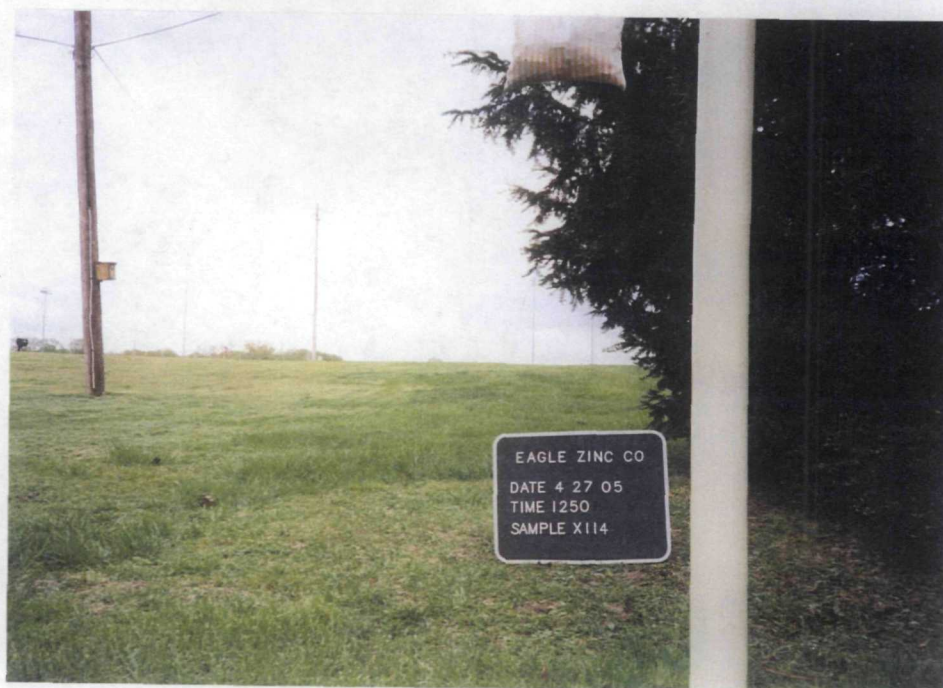
Photo Number 58.

Sample X114. The
sample consisted
of a light brown
clay loam collected
a depth of 0 to 3
inches.

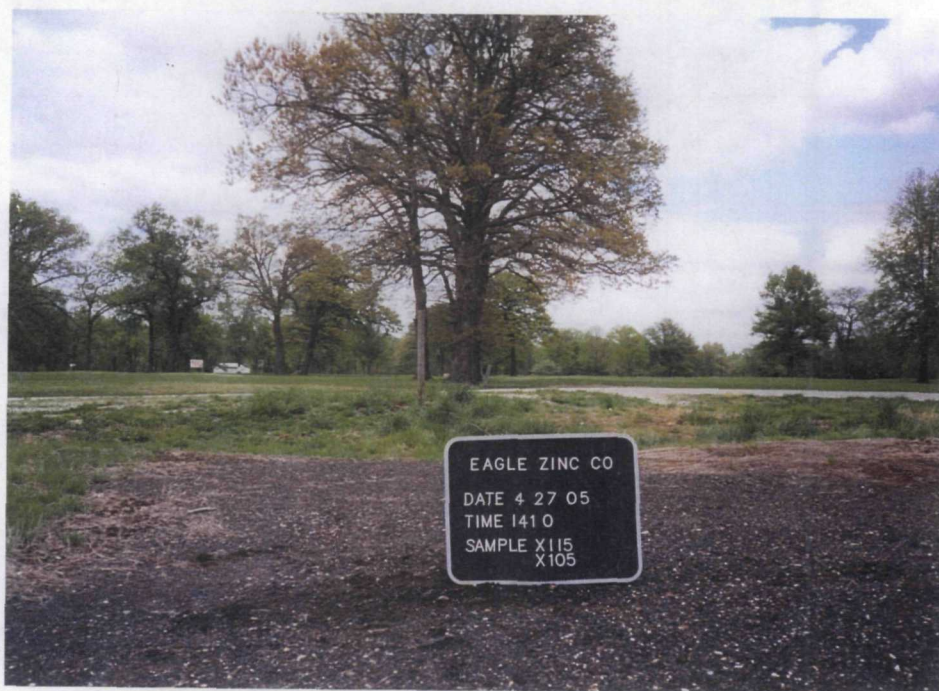
PHOTOGRAPH TAKEN BY: R. Casper
COMMENTS: Picture taken toward: North.
Photo Number 59.
Samples X115/X105
collected from an
athletic field
complex north of
site.

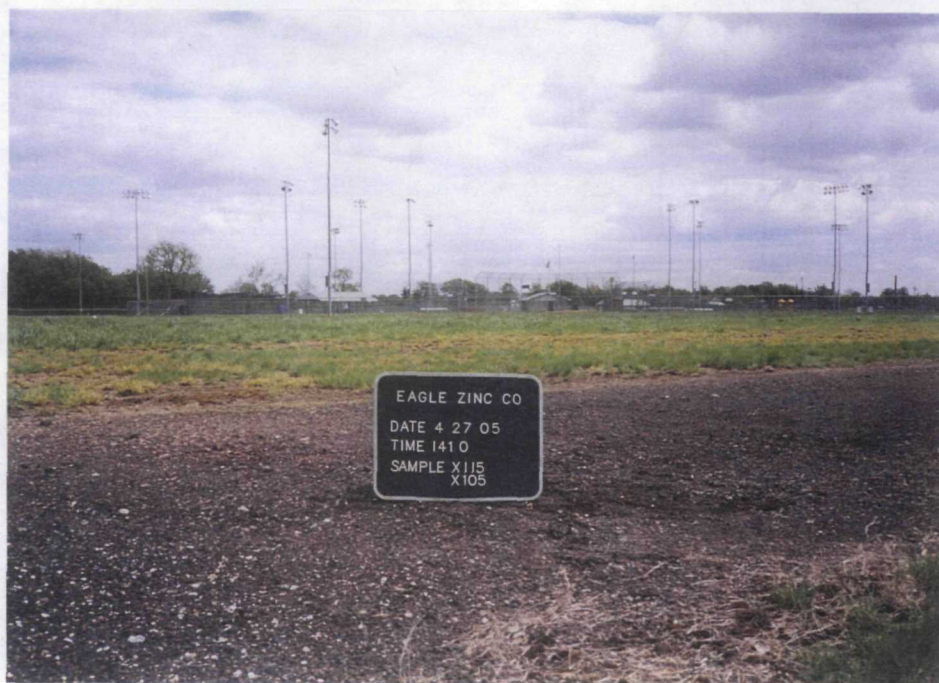
DATE: 4/27/05
TIME: 14:10
PHOTOGRAPH TAKEN BY: R. CASPER
COMMENTS: Picture taken toward: East.
Photo Number 60.
Samples X115/X105.
Duplicate samples
consisting of
cinders, slag
material and black
fines.

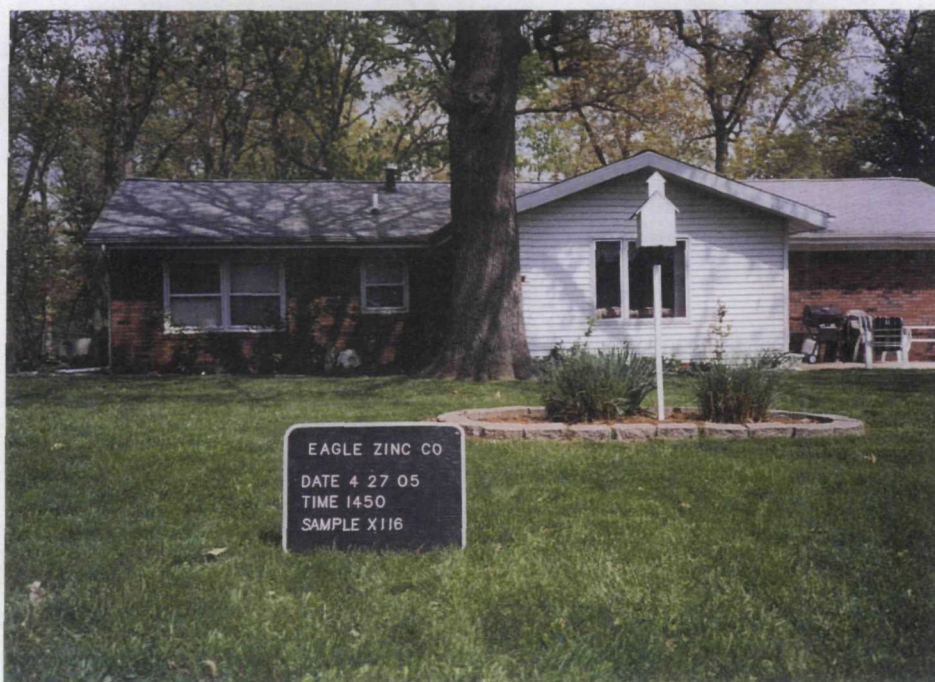
DATE: 4/27/05	SITE ILD#: 980606941	COUNTY: Montgomery
TIME: 14:50	SITE NAME: Eagle Zinc Co.	
PHOTOGRAPH TAKEN BY: R. Casper		
COMMENTS: Picture taken toward: East.		
Photo Number 61.		
Sample X116 was collected from a residential yard northeast of the site.

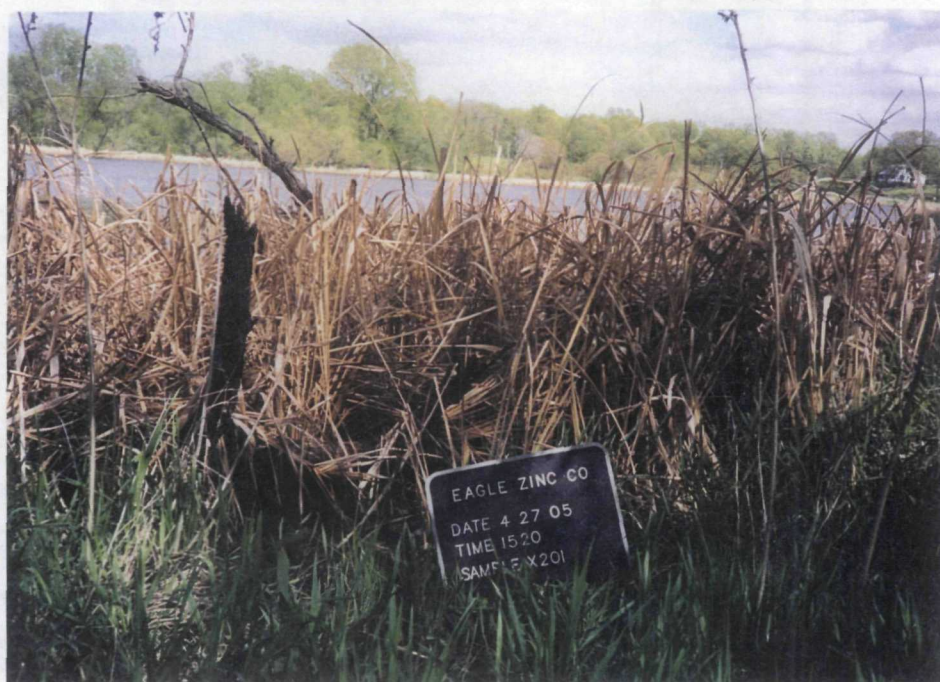
PHOTOGRAPH TAKEN BY: R. Casper
COMMENTS: Picture taken toward: East.
Photo Number 62.
Sample X201 was collected from lake Hillsboro at a residence located northeast of site.

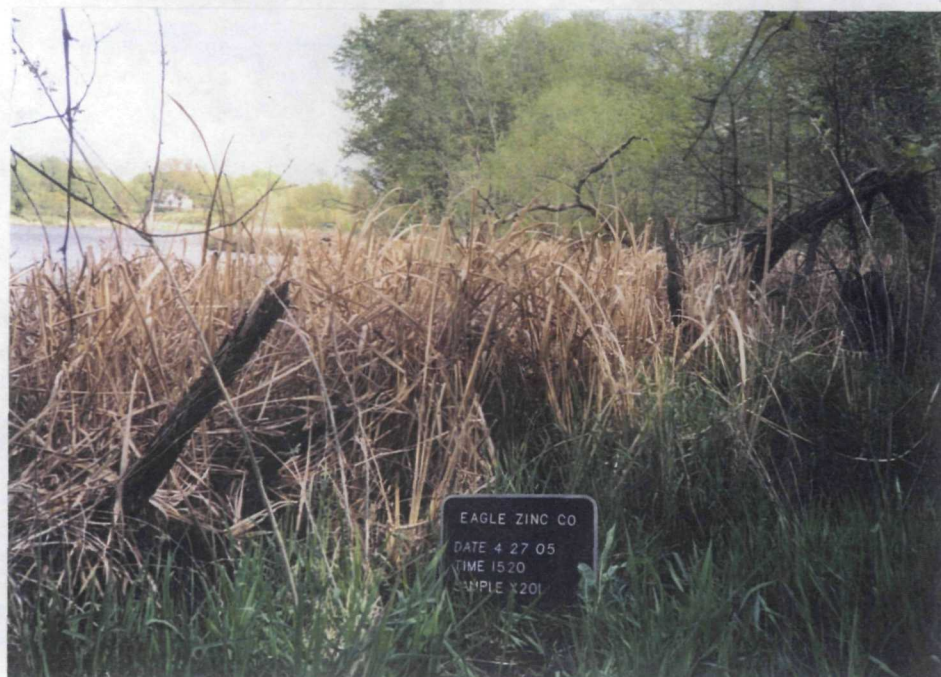
DATE: 4/27/05
TIME: 15:20
PHOTOGRAPH TAKEN BY: R. CASPER
COMMENTS: Picture taken toward: South.
Photo Number 63.
Sample X201. The sample consisted of a brownish gray silty clay collect- ed at a depth of 2 to 4 inches.

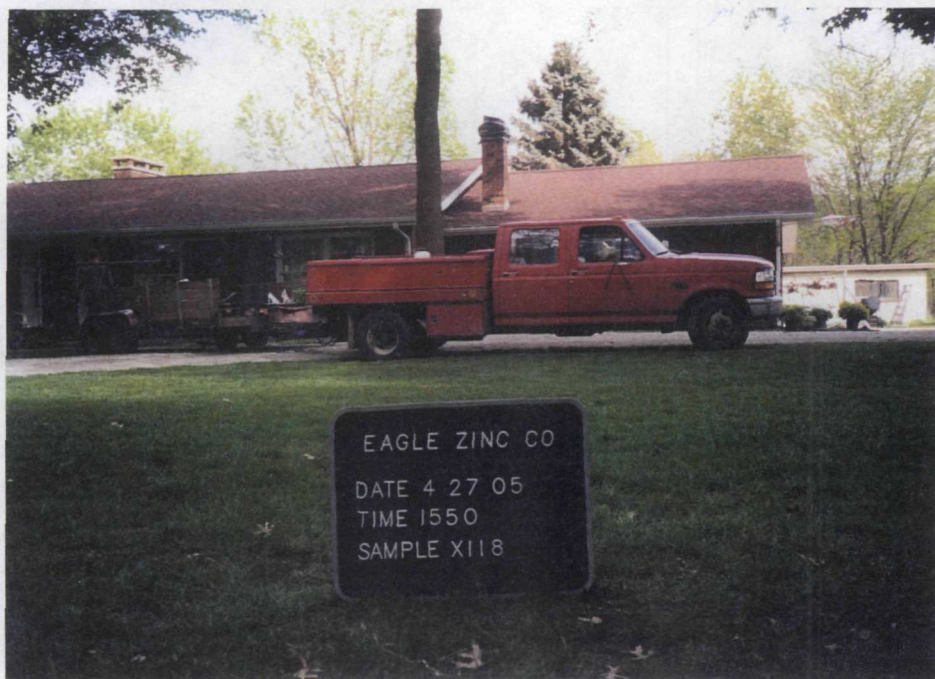
PHOTOGRAPH TAKEN BY: R. Casper
COMMENTS: Picture taken toward: East.
Photo Number 64.
Sample X118 was collected from a residential yard northeast of the site.

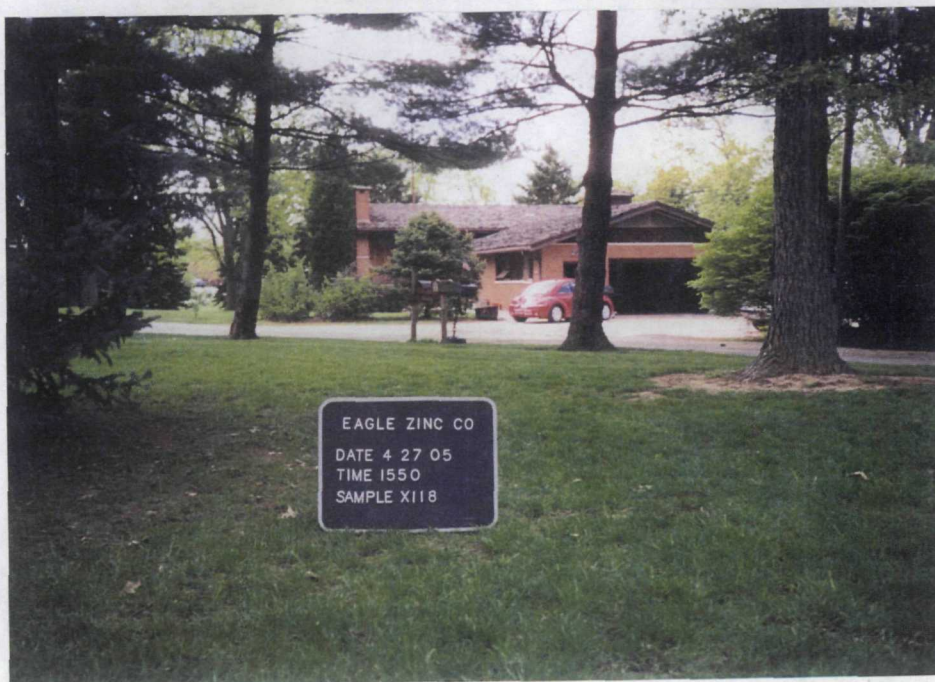
DATE: 4/27/05
TIME: 15:50
PHOTOGRAPH TAKEN BY: R. CASPER
COMMENTS: Picture taken toward: West.
Photo Number 65.
Sample X118. The sample consisted of a dark brown silty loam collect- ed at a depth of 1 to 3 inches.

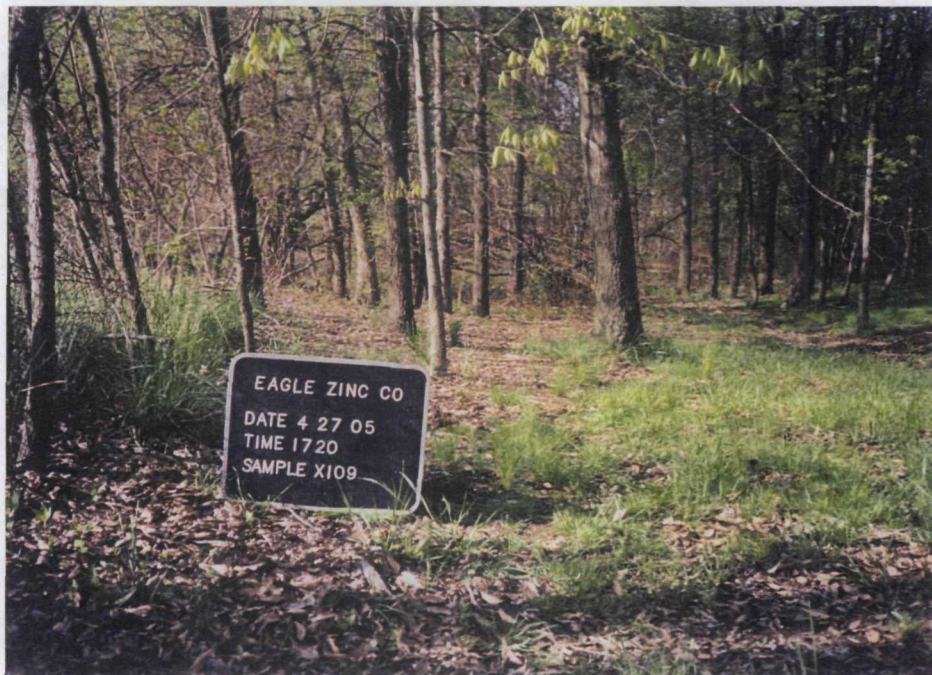
DATE: 4/27/05	SITE ILD#: 980606941	COUNTY: Montgomery
TIME: 17:20	SITE NAME: Eagle Zinc Co.	
PHOTOGRAPH TAKEN BY: R. Casper		
COMMENTS: Picture taken toward: North.		
Photo Number 66.		
Sample X109 was collected from a residential yard east of the site.

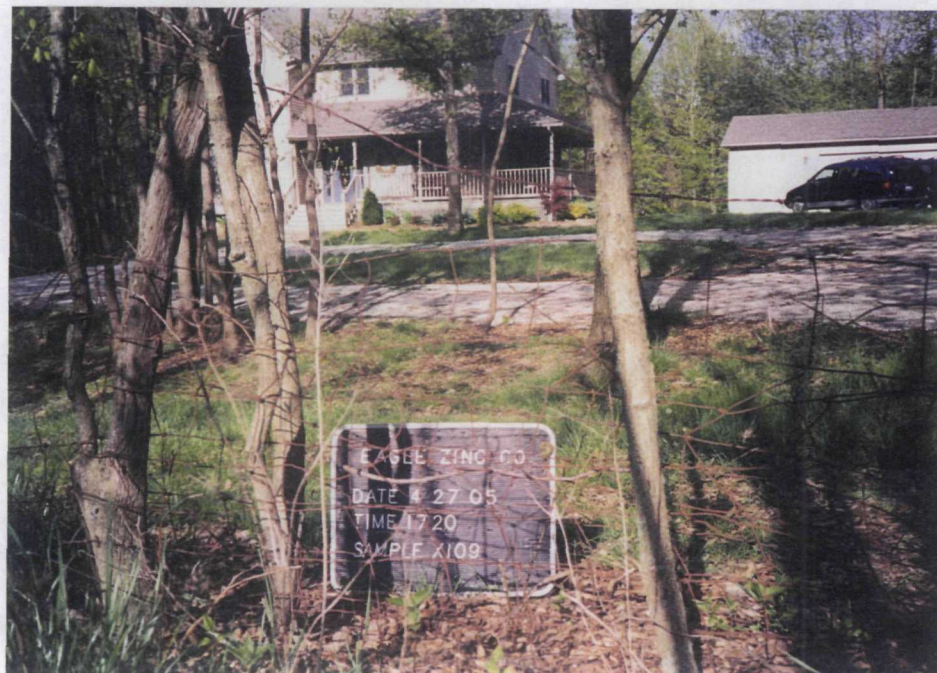
DATE: 4/27/05
TIME: 17:20
PHOTOGRAPH TAKEN BY: R. CASPER
COMMENTS: Picture taken toward: East.
Photo Number 67.
Sample X109. The sample consisted of a brown silty clay collected at a depth of 0 to 2 inches.

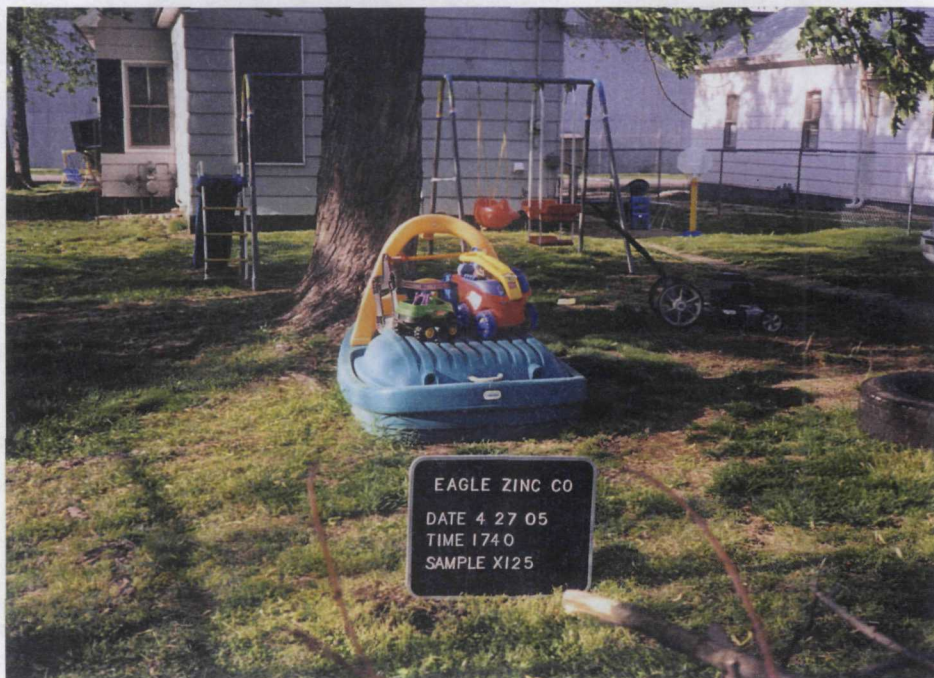
PHOTOGRAPH TAKEN BY: R. Casper
COMMENTS: Picture taken toward: North.
Photo Number 68.
Sample X125 was collected from a residential yard southeast of the site.

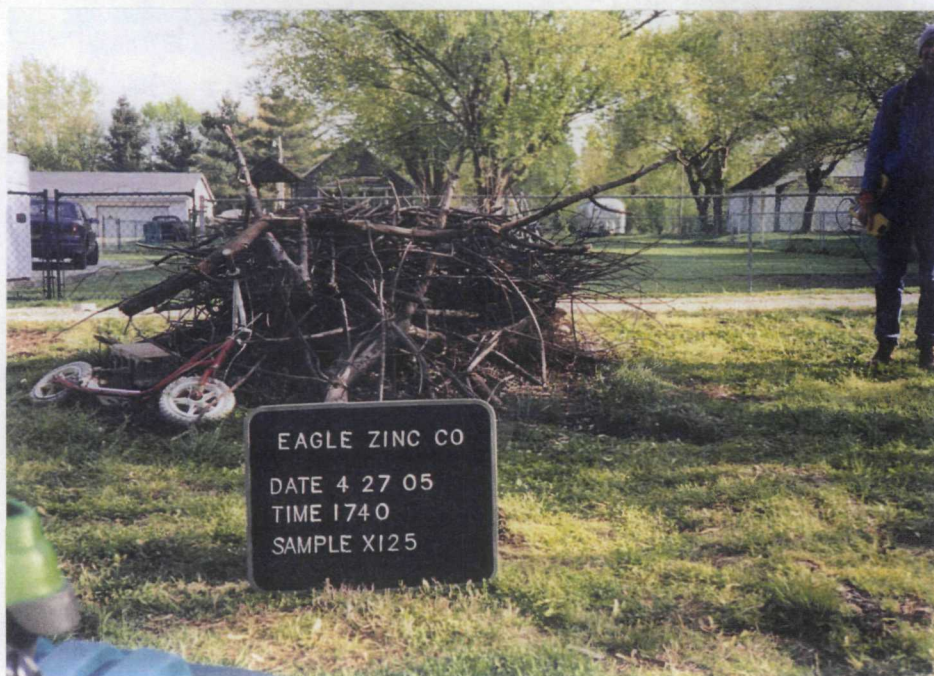
DATE: 4/27/05
TIME: 17:40
PHOTOGRAPH TAKEN BY: R. CASPER
COMMENTS: Picture taken toward: South.
Photo Number 69.
Sample X125. The sample consisted of a black loam with gravel collected at depth of 0 to 3 inches.

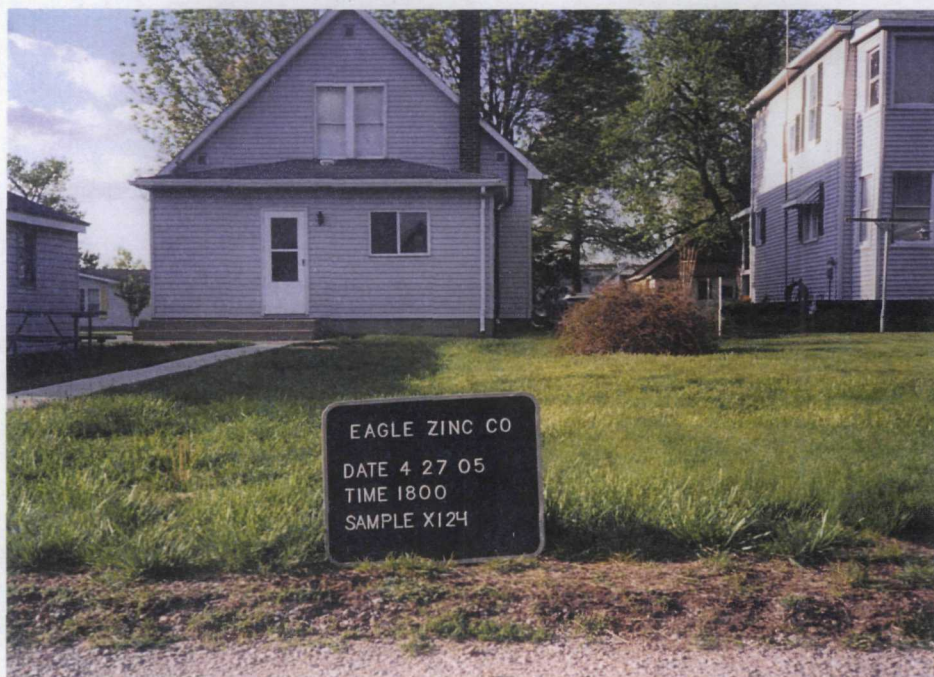
PHOTOGRAPH TAKEN BY: R. Casper
COMMENTS: Picture taken toward: North.
Photo Number 70.
Sample X124 was collected from a residential yard southeast of the site.

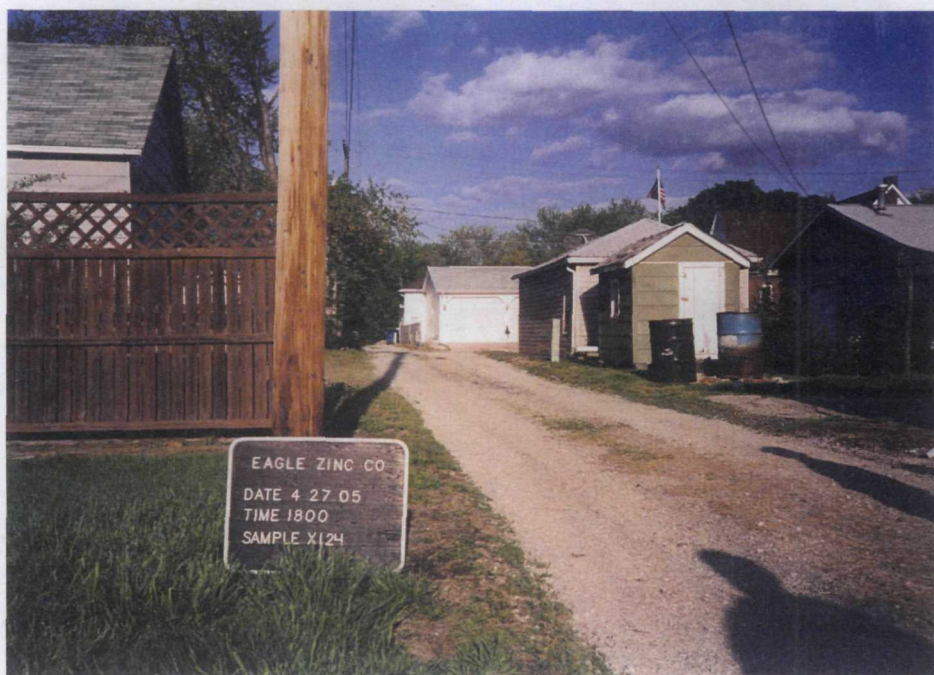
DATE: 4/27/05
TIME: 18:00
PHOTOGRAPH TAKEN BY: R. CASPER
COMMENTS: Picture taken toward: East.
Photo Number 71.
Sample X124. The sample consisted of a fine black slag material. Collected at depth of 3 to 6 inches.

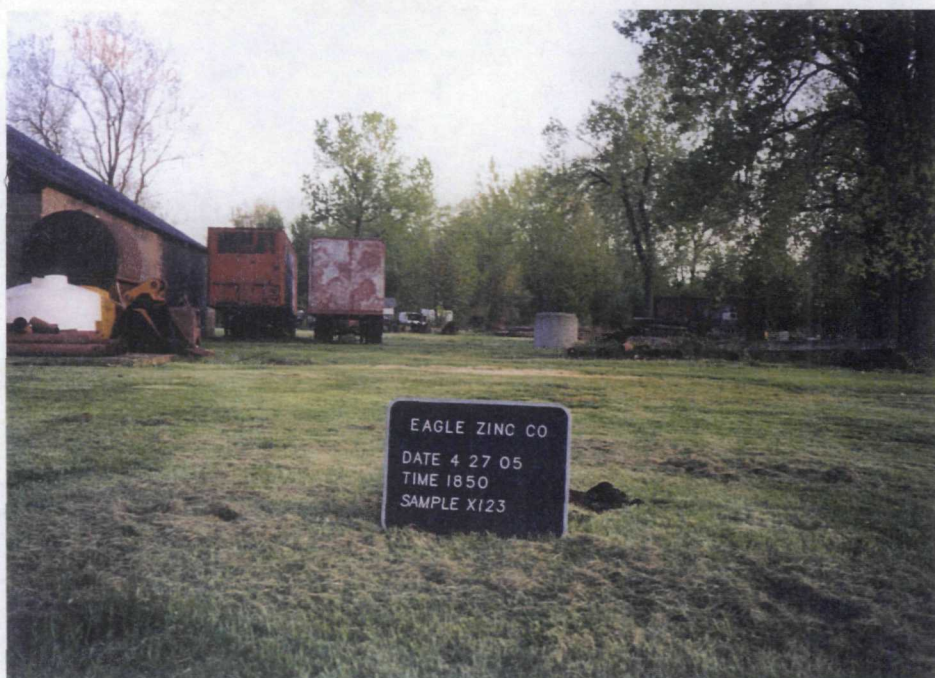
Photo Number 72.

Sample X123 was
collected from a
residential yard
southeast of the
site.

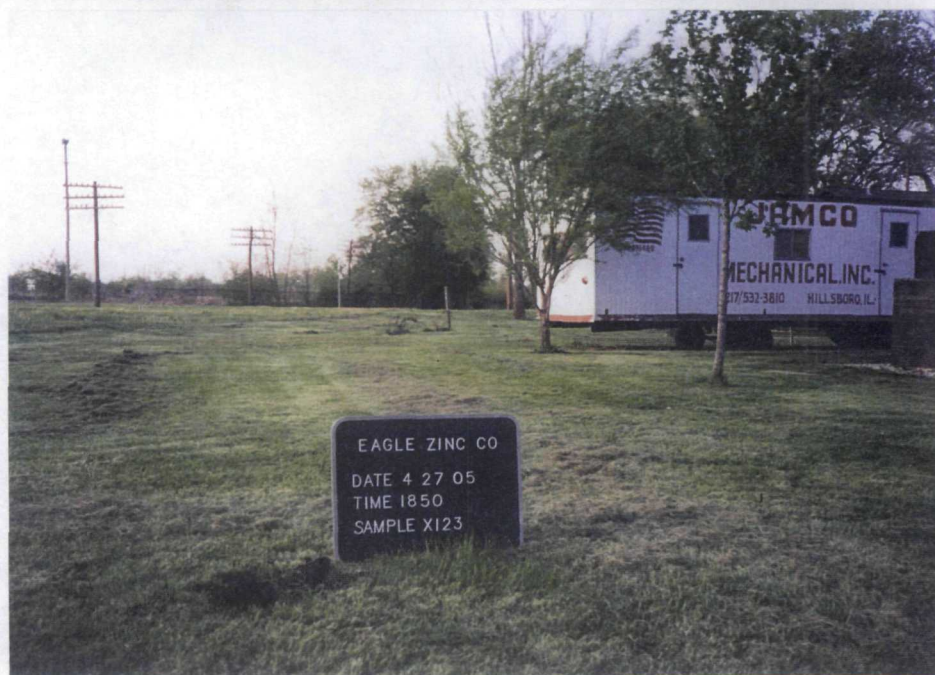
Photo Number 73.

Sample X123. The
sample consisted
of a black silty
loam with cinders
collected at depth
of 0 to 3 inch.

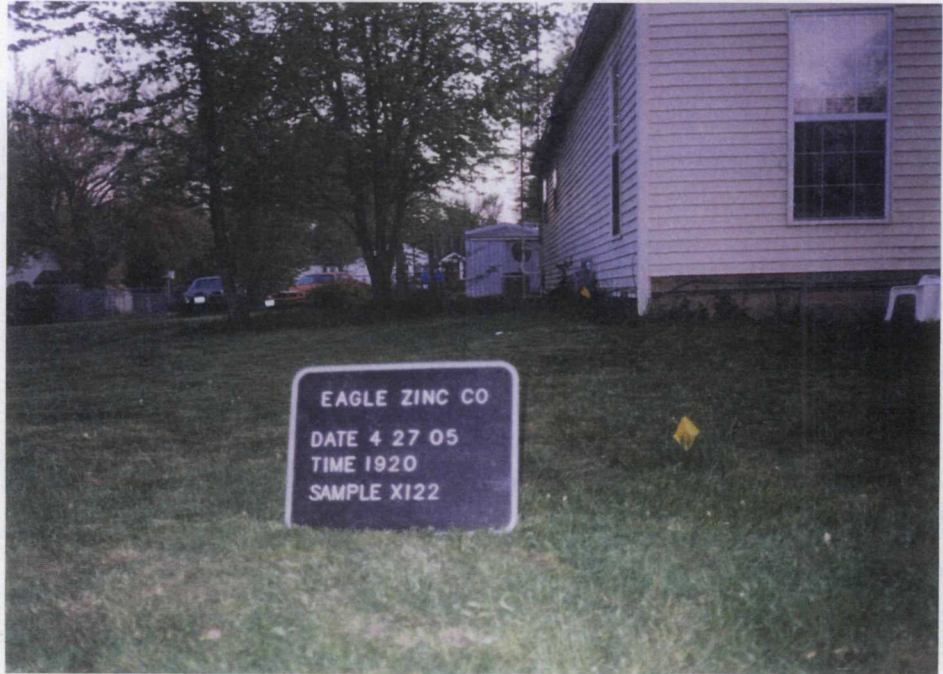
DATE: 4/27/05	SITE ILD#: 980606941	COUNTY: Montgomery
TIME: 19:20	SITE NAME: Eagle Zinc Co.	
PHOTOGRAPH TAKEN BY: R. Casper		
COMMENTS: Picture taken toward: South.		
Photo Number 74.		
Sample X122 was collected from a residential yard east of the site.

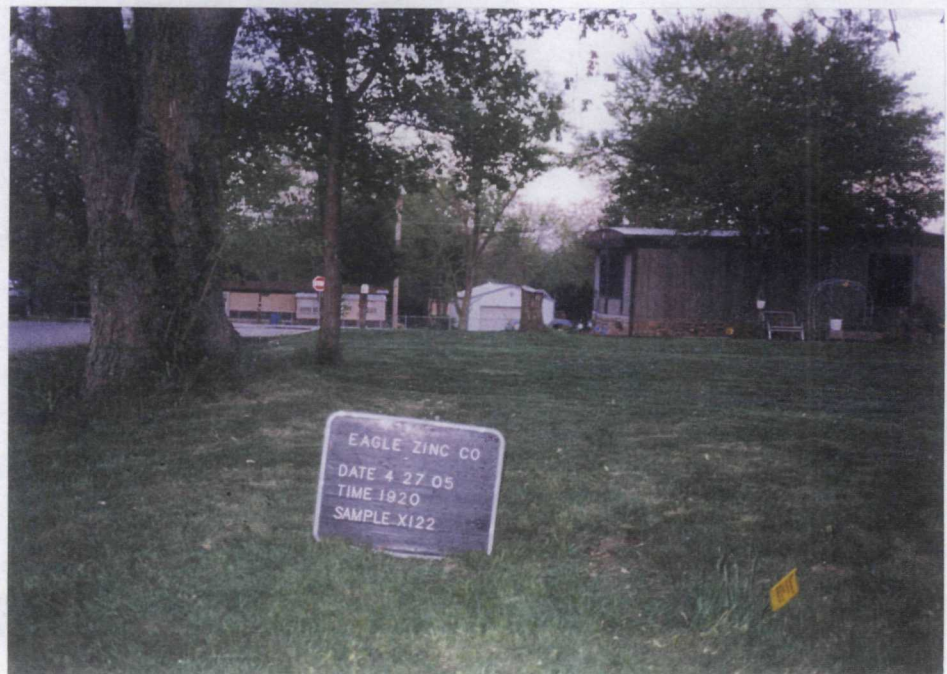
DATE: 4/27/05
TIME: 19:20
PHOTOGRAPH TAKEN BY: R. CASPER
COMMENTS: Picture taken toward: East.
Photo Number 75.
Sample X122. The sample consisted of a brown silty loam collected at a depth of 2 to 3 inches.
